**PHASE I REPORT  
NATIONAL DAM INSPECTION PROGRAM**

**NAME OF DAM:** Brookville Water Works Dam  
**STATE LOCATED:** Pennsylvania  
**COUNTY LOCATED:** Jefferson  
**STREAM:** North Fork Creek, a Tributary of Red Bank Creek  
**SIZE CLASSIFICATION:** Small  
**HAZARD CLASSIFICATION:** Significant  
**OWNER:** Borough of Brookville  
**DATE OF INSPECTION:** April 24, 1980 and April 30, 1980

BROOKVILLE WATER WORKS DAM  
NDI I.D. PA-422  
DER I.D. 33-2  
APRIL 24, 1980

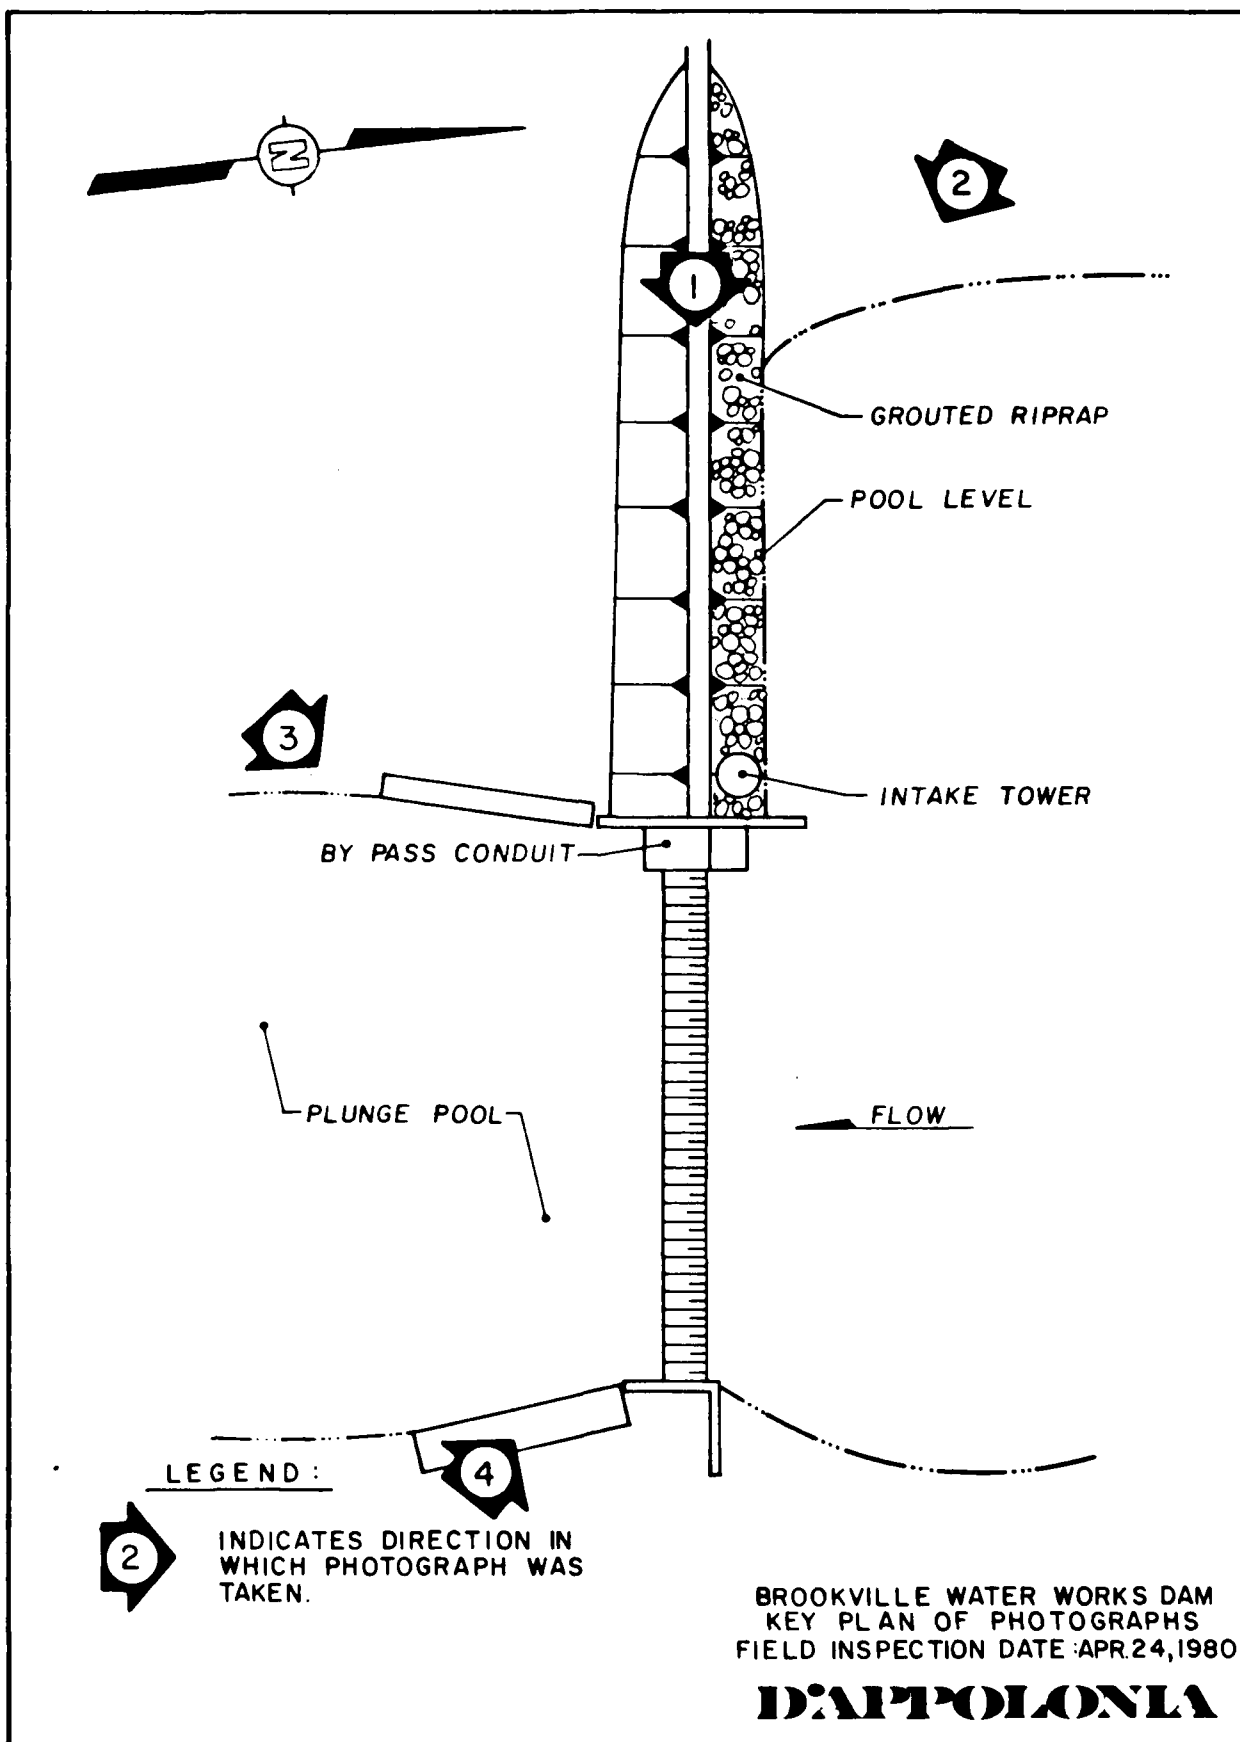
Photograph No. 1  
Dam crest (looking east).

The crest of the dam was surveyed relative to the spillway crest elevation and it was found that the dam crest was essentially at the design crest level with a minor low spot located at the right abutment embankment interface. The dam crest profile is illustrated in Plate 6. The downstream and upstream slopes were surveyed and were found to be reasonably within the design slope of 2H to 1V.
